**From:** [Casolo, Louis](#)  
**To:** [Rosenson, Valerie](#); [Jacobson, Jonathan](#); [Figueroa, Anabel](#)  
**Cc:** [Orgera, Ernie](#); [Turk, Thomas](#); [Barisic, Zvonko](#)  
**Subject:** Weed Ave. Seawall  
**Date:** Wednesday, May 02, 2018 3:45:24 PM  
**Attachments:** [IMG\\_1944.jpg](#)  
[IMG\\_1946.jpg](#)  
[IMG\\_1947.jpg](#)  
[IMG\\_1953.jpg](#)  
[IMG\\_1955.jpg](#)  
[IMG\\_1951 \(2\).jpg](#)

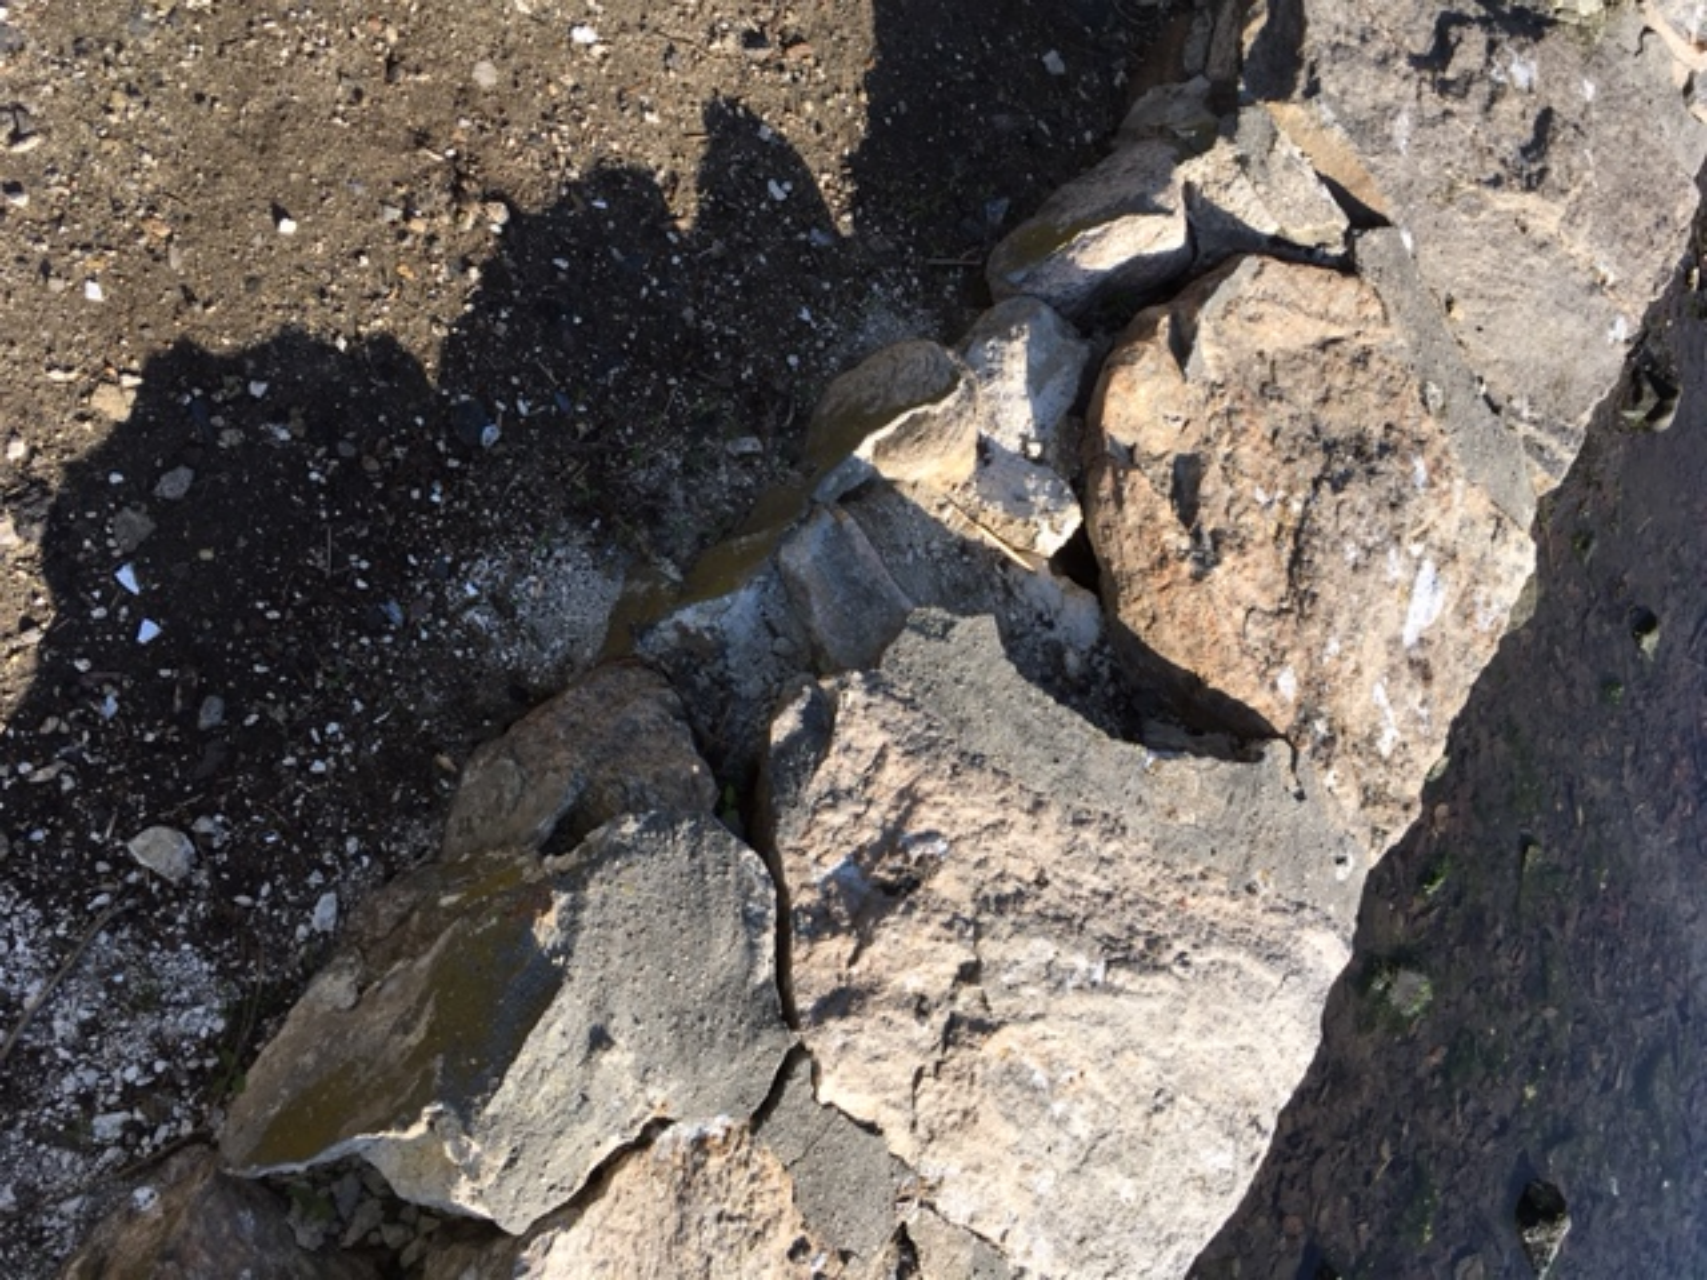
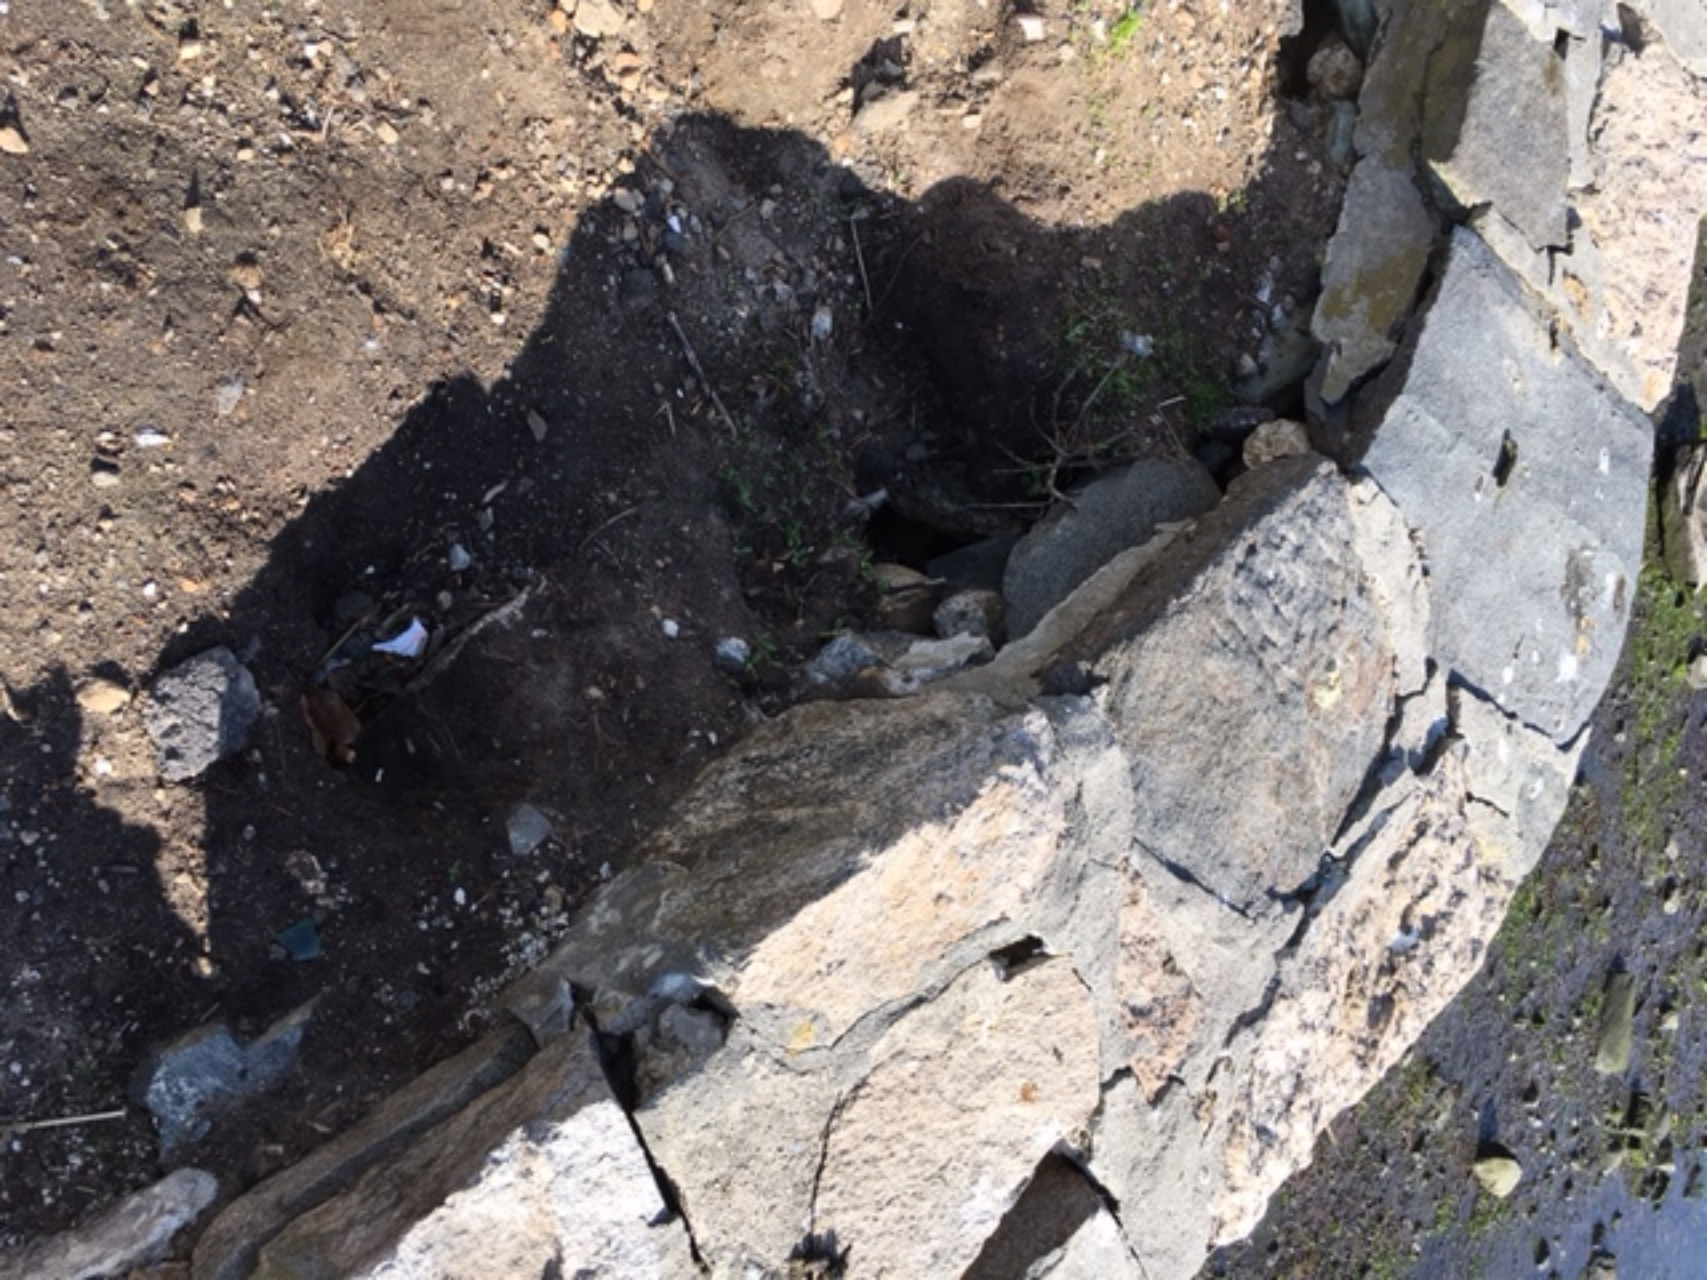
I noticed several areas where the wall along its length of Weed Ave. showed signs of deterioration including missing mortar and loose capping stone masonry (see first 2 photos) and areas of complete wall failure. The areas where failures are located are located in areas well off the road and areas nearer to the road. (see photo 3 for an area off the road). The failure areas near the road were field measured and are about 200 l.f. long (see 4<sup>th</sup> and 5<sup>th</sup> photo).

My office will address the areas (200 l.f.) of failures closest to the road as a first priority and then follow up with areas needing some rehabilitation as a second priority due to the severity, and available funds. The wall is very long.

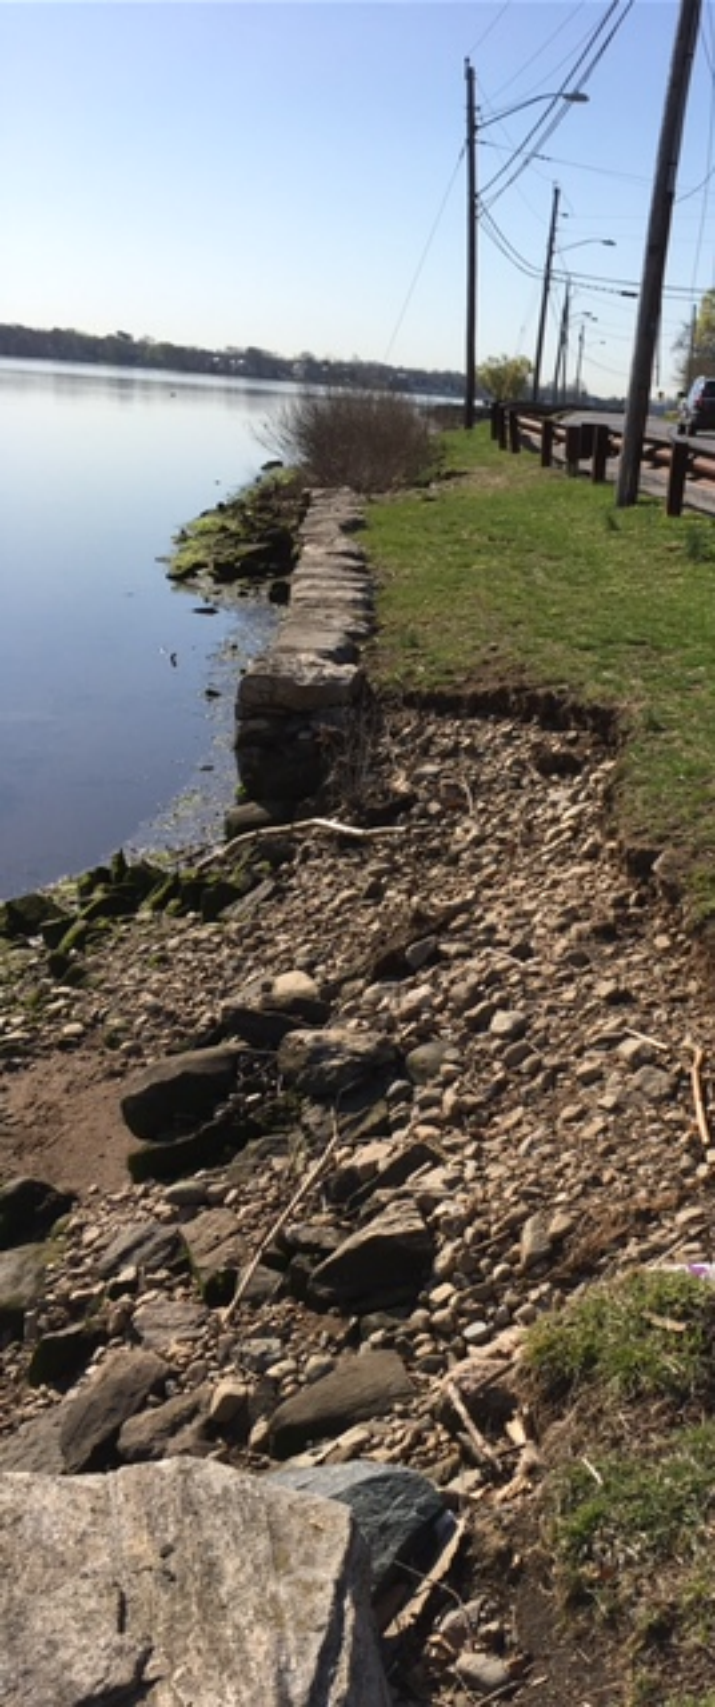
Other than some undermining in a few areas along the east side shoulder of Weed Ave. (see photo 6), the roadway was not visibly undermined in the areas of the wall collapse or in areas impacting the travel lane at this time.

In select areas of shoulder undermining, which are outside of the wall failure areas, I will request by way of this email that the road and maintenance dept. fill these holes with hot mix asphalt. At this time, there does not appear to be any other work related to undermining on the road.
