Public Safety & Health Committee Board of Representatives

**Item 2– “REVIEW; Collapse of Outdoor Patio at
Allure Apartment Building Located in Harbor Point”**

**Allure
Block P4-P5
850 Pacific Street
Building B –**
Final CO
Issued August 28,
2020

Partial slab failure
incident happened
around 2:30 PM on
Feb 1, 2022

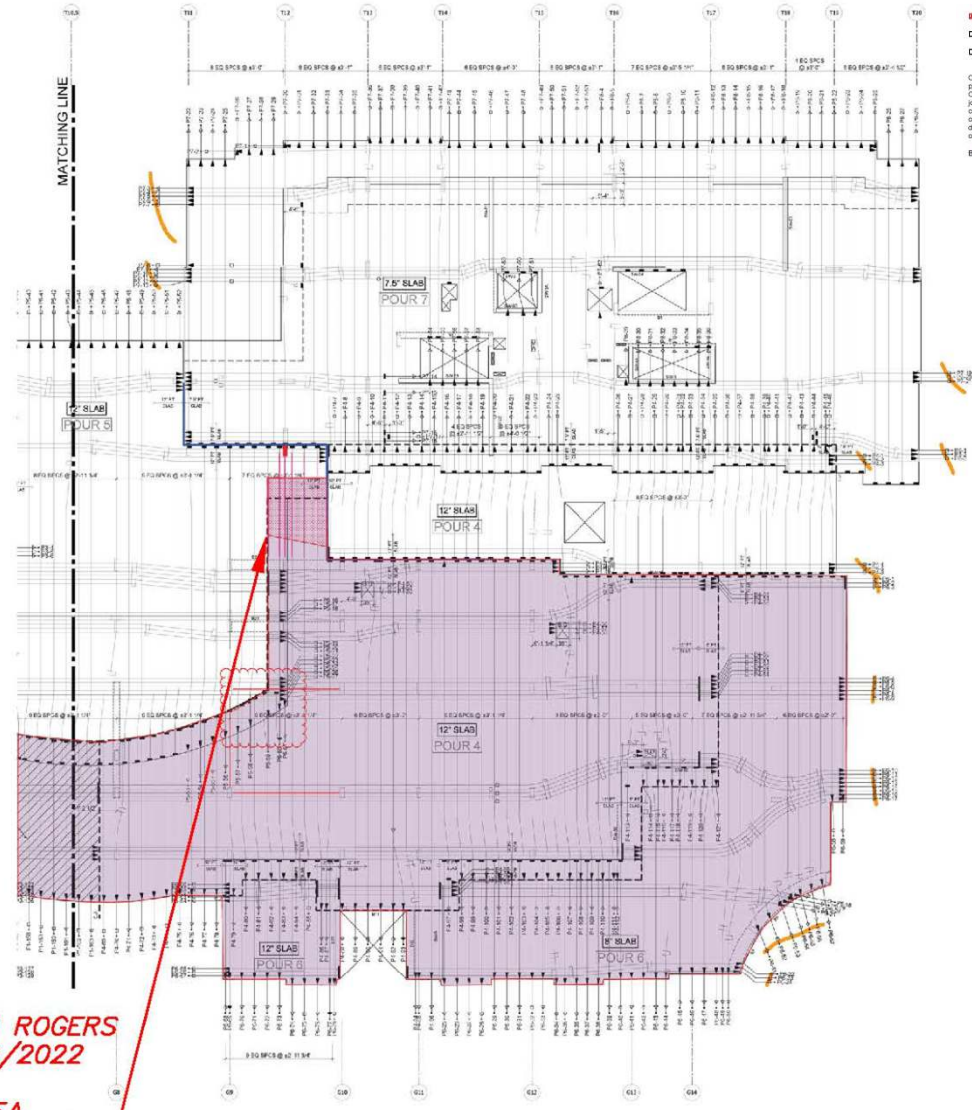
**HENDERSON ROGERS
LETTER 2/9/2022
IDENTIFIED
FAILURE AREA
SK-3**

The slab structure at the 5th level amenity deck and the lower garage levels consists of cast-in-place, two-way, flat plate construction reinforced with post tensioning and conventional mild steel. The tendons are banded in the north-south direction, with uniformly spaced bundles of three (3) or four (4) in the east-west. The collapsed area of slab is approximately 16'-0" x 20'-0" and bound within structural grids G9/ G10 and TE/ GE (See attached SK-1 partial plan). The failed section bears on the 4th level garage at the east side and is still connected near the 5th level beam on the west side. There is a ten (10) inch step in the slab around the failure boundaries of the north and east sides and a transition zone or widened/ deepened slab soffit to allow passage and transition of the tendons from the "high" to "low" slab (See attached SK-2, Section 10/ S4.10). The transition step is shown in section 10/S4.10 as monolithic and without a construction joint(s). A review of the structural PT layout plan S105PT-B and the post tension shop drawings indicates the uniform tendons to be continuous through the slab step transition and extending west to the opposite end of the garage, approximately 80 feet (See attached SK-2 and 3).

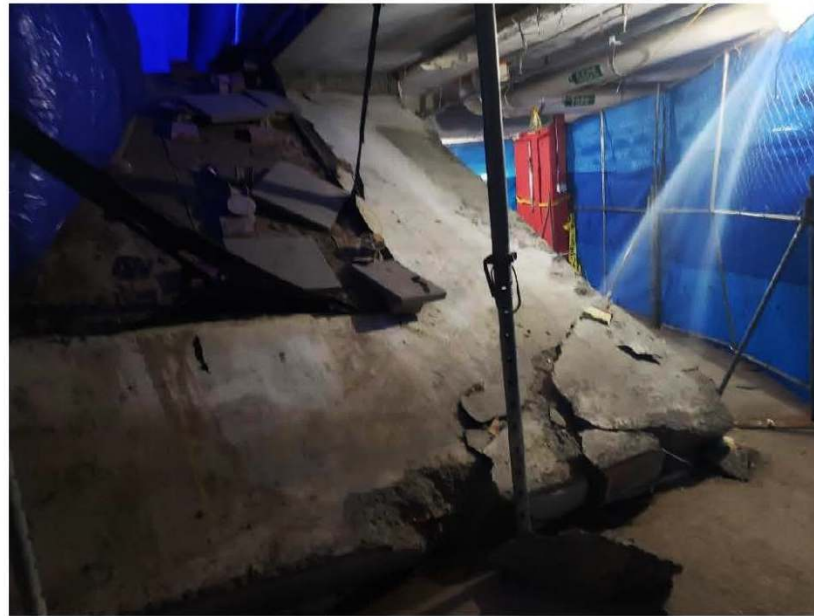
Figure 1- Partially Collapsed 5th Level Slab. Looking East to West

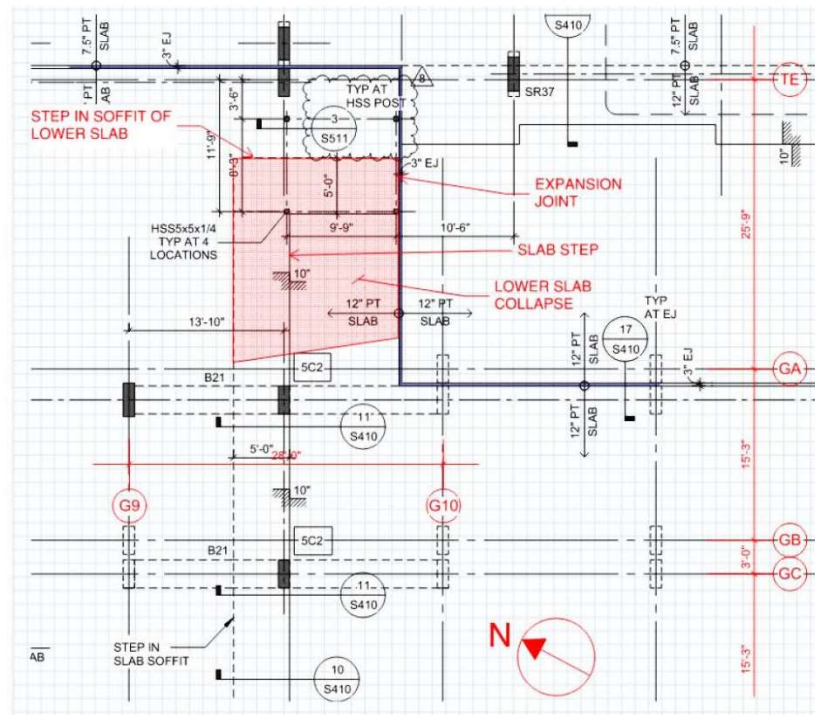
Figure 2- Partial Floor Plan from HR Report

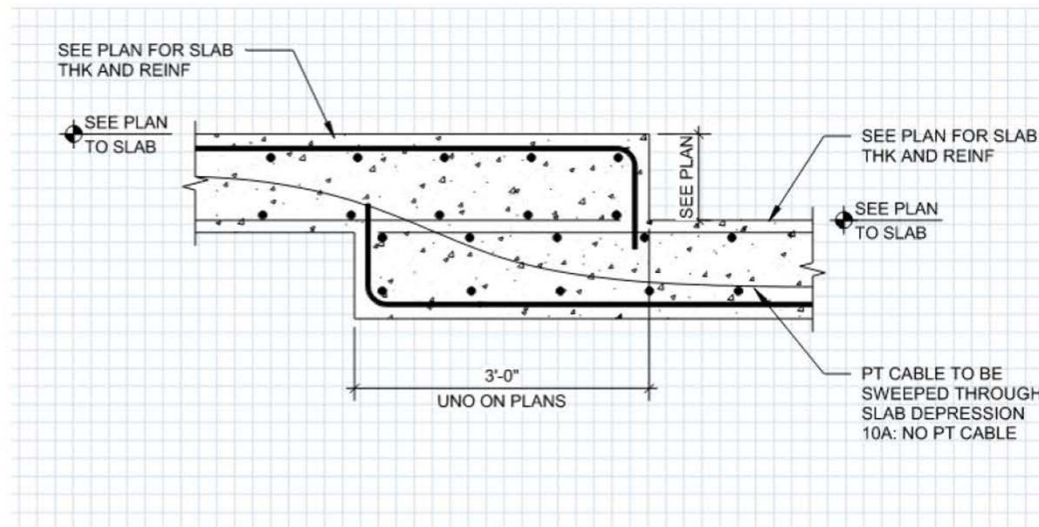
Figure 3- PT Step Detail from Original Drawings and HR Report

THE AS-BUILT CONDITION OF THE STEP APPEARS TO BE IN NON-CONFORMANCE WITH THE STRUCTURAL DRAWINGS AND PT SHOP DRAWINGS. ENGINEER-OF-RECORD WAS NOT NOTIFIED BY THE SPECIAL INSPECTOR ABOUT THE NON-CONFORMANCE. NO SKETCHES/DRAWINGS/CALCULATIONS WERE PROVIDED TO THE EOR FOR REVIEW. NO, WE DO NOT HAVE SPECIAL INSPECTION REPORTS FOR THIS AREA, AS THEY WERE NOT PROVIDED TO THE EOR.

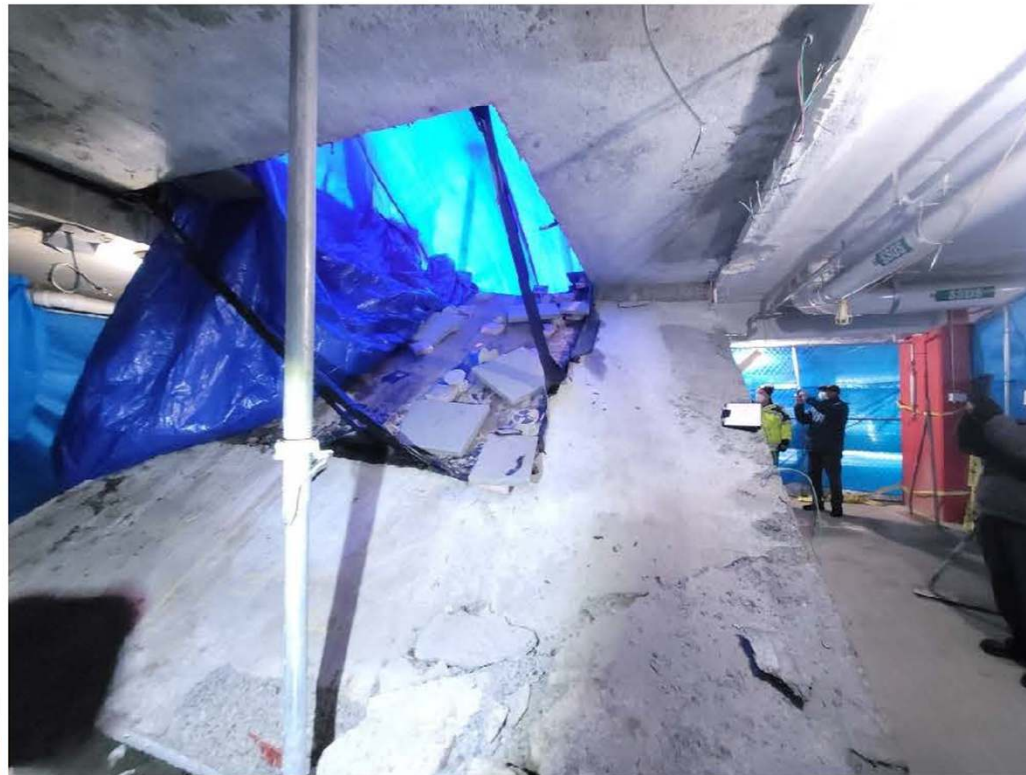
Figure 4- Partially Collapsed Slab looking West

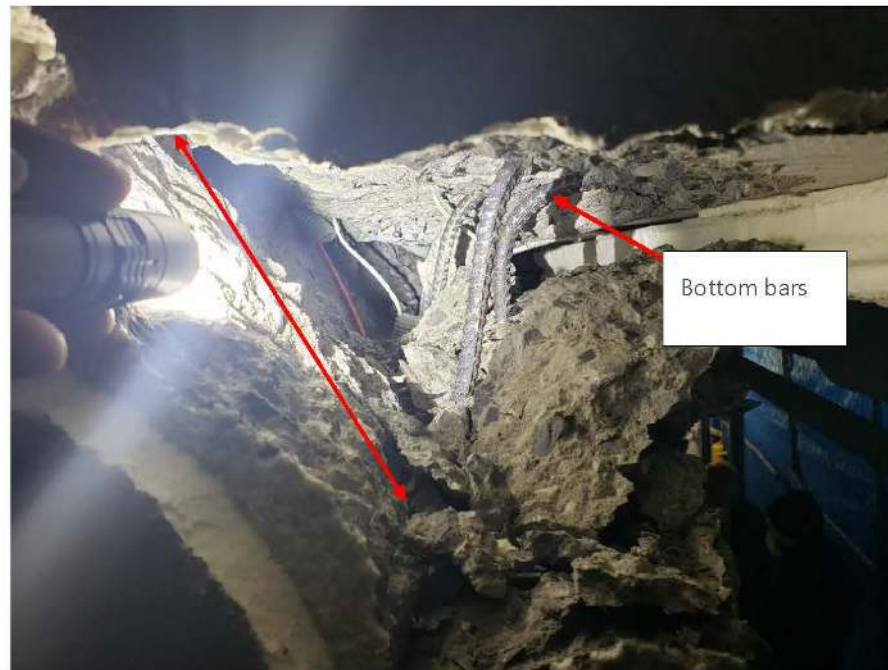
Figure 9- No Top Steel Crossing Failure Plane Looking North to South at West Failure Plane

- The construction documents show both a top mat and bottom mat of conventional reinforcement within the PT slab with bars in both directions. In the area of the collapse there is no top steel. Is there supposed to be a top mat of reinforcement? Was this missing steel identified by the special inspector prior to concrete placement? Can you provide the specific special inspection reports for this location? In the event the top steel is missing, how do you plan to identify and assess the extent of the non-confirming steel?

FOR CLARIFICATION, THERE IS ONLY SUPPOSE TO BE #4 MAT AT THE BOTTOM OF THE SLAB IN EACH DIRECTION. ADDITIONAL TOP BARS ARE PROVIDED IN EACH DIRECTION AT COLUMN LOCATIONS. NO, ENGINEER-OF-RECORD WAS NOT NOTIFIED OF ANY MISSING STEEL REINFORCEMENT PRIOR TO CONCRETE PLACEMENT. NO, WE DO NOT HAVE SPECIAL INSPECTION REPORTS FOR THIS LOCATION. SLAB ASSESSMENT FOR MISSING STEEL WILL BE CONDUCTED IN PHASE 2.

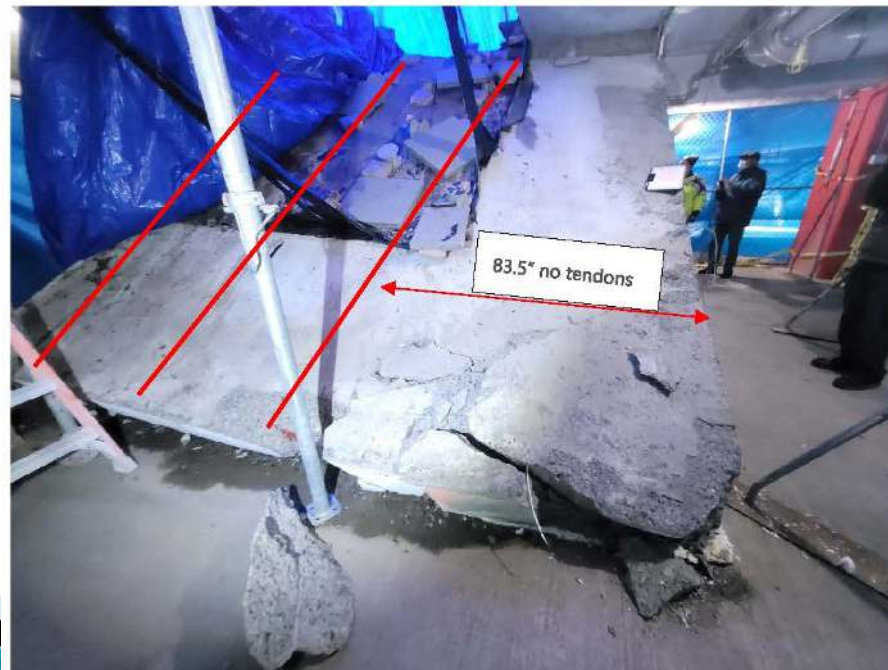
Figure 10- PT Layout at Slab Looking East to West

- Is the identified PT layout correct in the area of the collapsed slab? Are there only supposed to be 3 groups of tendons? The drawings seem to indicate that the tendons should be equally spaced at approximately 3 ft. on center which would indicate that 1 additional band of tendons should have been provided in this area. For the remaining portion of the lower slab that spans west to the exterior wall, is the correct post tensioning layout provided or is a band of tendons missing? If missing, how do you plan to further assess this condition? Can you provide the specific special inspection reports for this location?

NO, THE AS-BUILT CONDITION OF THE PT LAYOUT APPEARS TO BE IN NON-CONFORMANCE WITH THE STRUCTURAL DRAWINGS AND PT SHOP DRAWINGS. NO, THERE SHOULD BE SIX (6) BUNDLES OF PT CABLES EXTENDING FROM LOW SLAB INTO THE HIGH SLAB AT THE STEP AND ANCHORING AT THE EXPANSION JOINT. SLAB ASSESSMENT FOR MISSING PT CABLES WILL BE CONDUCTED IN PHASE 2. ENGINEER-OF-RECORD WAS NOT NOTIFIED BY THE SPECIAL INSPECTOR ABOUT THE NON-CONFORMANCE. NO, WE DO NOT HAVE SPECIAL INSPECTION REPORTS FOR THIS AREA.

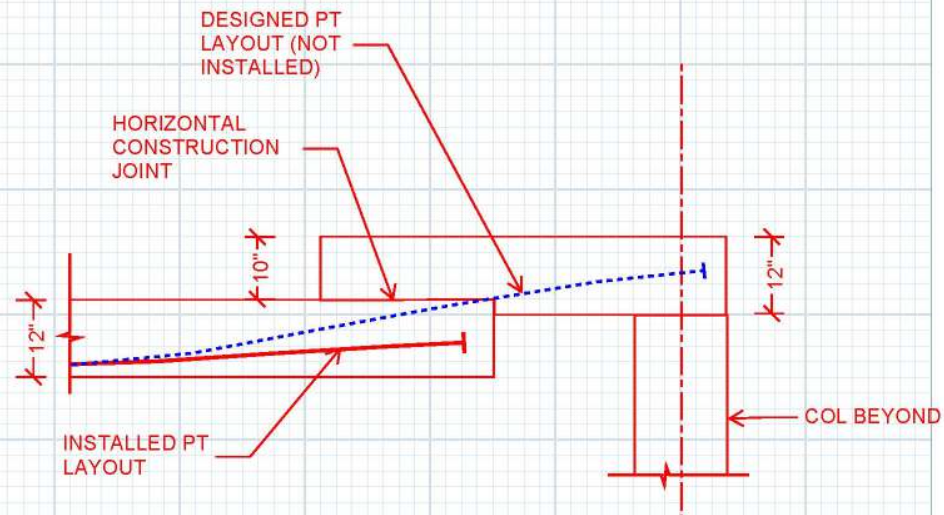
In our recent discussions and a review of the photographs we found that the tendons across the transition zone are missing, resulting in discontinuity of the post tension reinforcing across the slab step and the ability of the slab to span to beyond the transition slab step. Additionally, it appears from the photographs that a horizontal construction joint was placed at the step transition, with no shear transfer mechanism. A 2-inch recess was observed from the underside of the remaining 5th level slab. (See attached SK-4 and Photo).
